**MINIMALLY INVASIVE ACTIVE FIRE PROTECTION
SYSTEMS IN HERITAGE TIMBER BUILDINGS**

**A thesis submitted in fulfilment of the requirement for the
degree of Master of Science (Built Environment)**

**Kulliyyah of Architecture and Environmental Design
International Islamic University Malaysia**

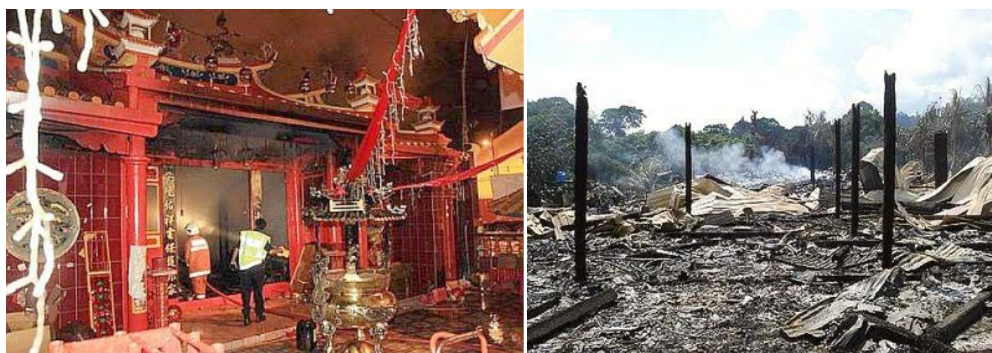
Figure 1.1: Aftermath of fire in Ho Ann Kiong Temple (left) and Punan Bah Longhouse (right)
(Source: thestar.com.my)

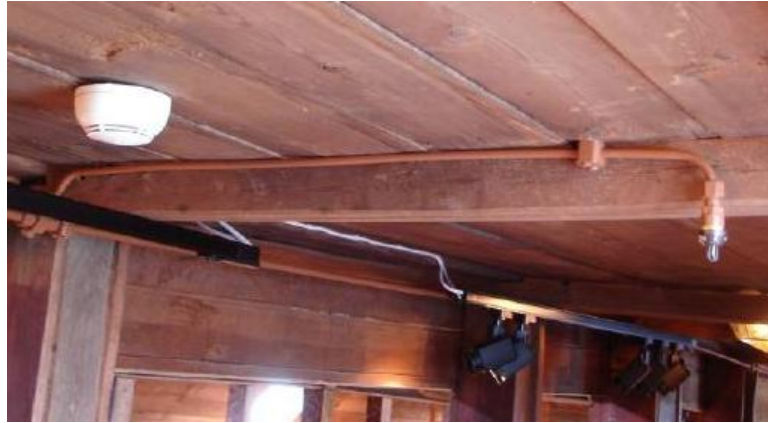
Figure 1.2: Exposed sprinkler piping and smoke detector
(Source: Arvidson [2006])

Another main issue that occurs during the installation of fire protection system in heritage timber building is the appearance of the equipments stands out differently compared to the building fabric, as shown in Figure 1.2. The installation of the fire protection system should not contradict with the design elements of the building since it will most likely lose the purpose of historical preservation. As mentioned by Allwinkle, Bell et al. (1997), changes should only be made where it is deemed absolutely essential for the building's safety. This is further supported by Siemens Switzerland Ltd. (2015), in which they stated that the procedures involved should be done with the least amount physical impact towards the fabric and decor of the building. In the context of heritage timber buildings, the installation of the fire protection system should be carried out with minimally invasive methods.
